PHOTOGRAPHIC INTERPRETATION REPORT

~~TOP SECRET~~  
**SOUTHEAST ASIA  
ACTIVITY REPORT**

**SELECTED TRANSPORTATION  
AND INFILTRATION  
COMPENDIUM  
22-28 SEPTEMBER 1966**

NPIC/R-344/66  
SEPTEMBER 1966

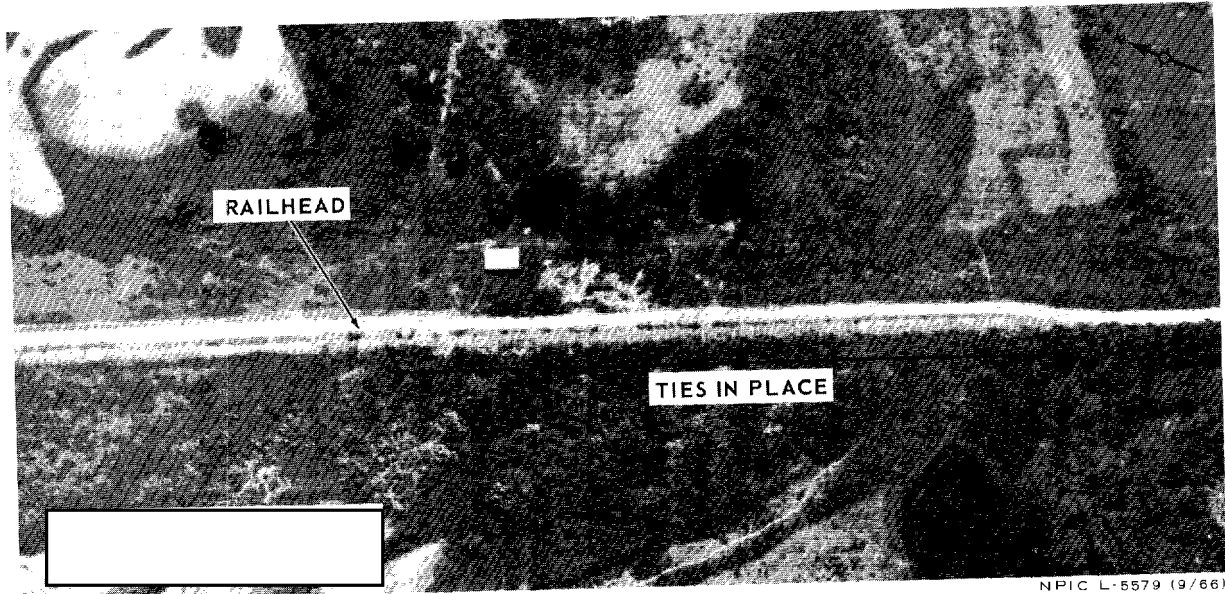
Reconstruction of the Vinh/Dong Hoi Rail Line continues with an obvious emphasis on the construction of river and stream crossings. Track is being laid at a pace well below the construction rate permissible in an area of pre-existing railbeds and railroad tunnels (Figure 16), however this probably reflects the difficulties encountered in constructing an adequate river crossing at Thuong Phong Trang. [REDACTED] a total of only 1.4 nm of track was laid from UTM XE067795 to XE286778 (Figure 15).

FIGURE 15. PRESENT RAILHEAD, VINH/DONG HOI RAIL LINE, NORTH VIETNAM.

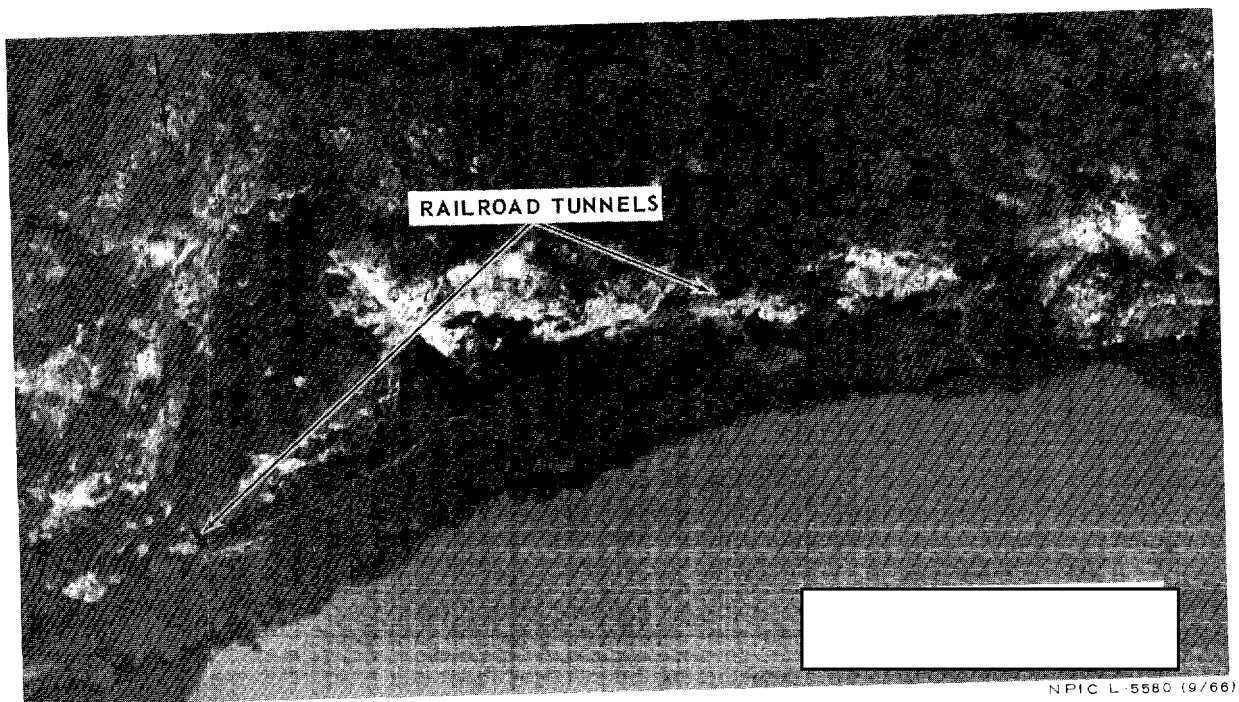
FIGURE 16. ABANDONED RAILBED, VINH/DONG HOI RAIL LINE, NORTH VIETNAM.

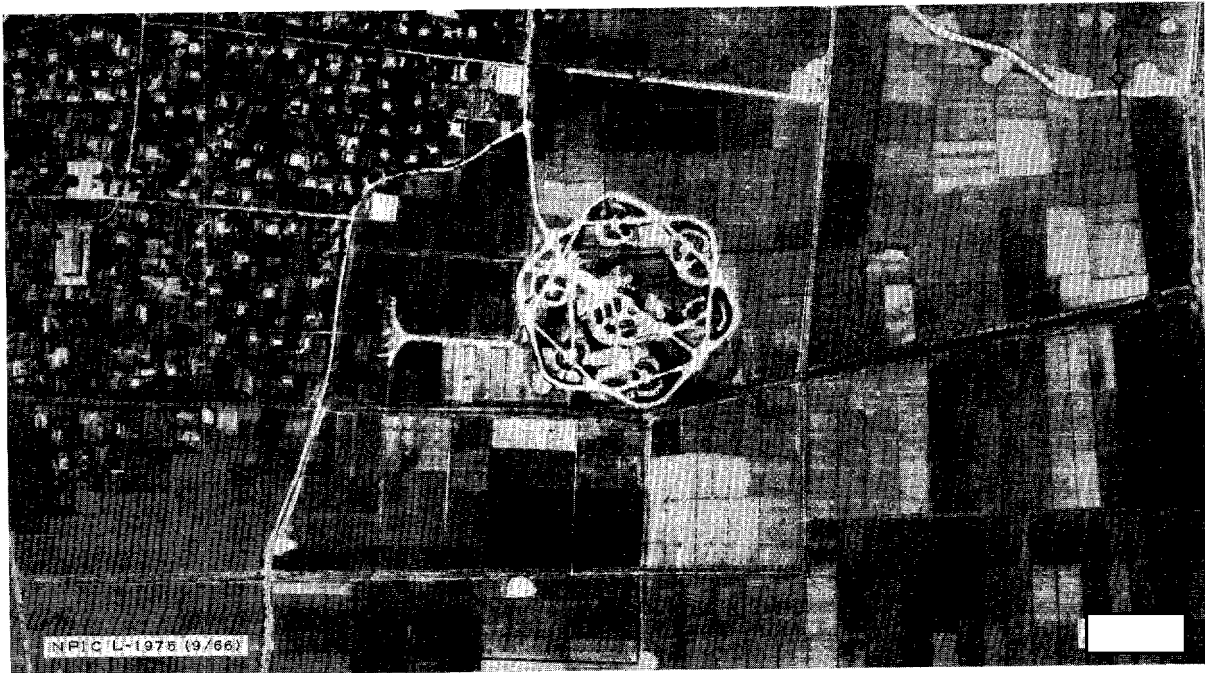
Hai Phong SAM Site A29A-2

Location: 9.3 nm WNW of Hai Phong      Negation Date:   
 Configuration: Star  
 Status: Complete  
 Launch Facilities: 6 positions, revetted, unoccupied  
 Electronic Facilities: Central guidance area is revetted, unoccupied  
 Site Support Facilities: No buildings; no missile-hold positions  
 Security Measures: None  
 Remarks: No AAA sites within 1 nm  
 Vehicles & Equipment: 2 possible transporters and 2 vans approximately  
 500 ft west of site

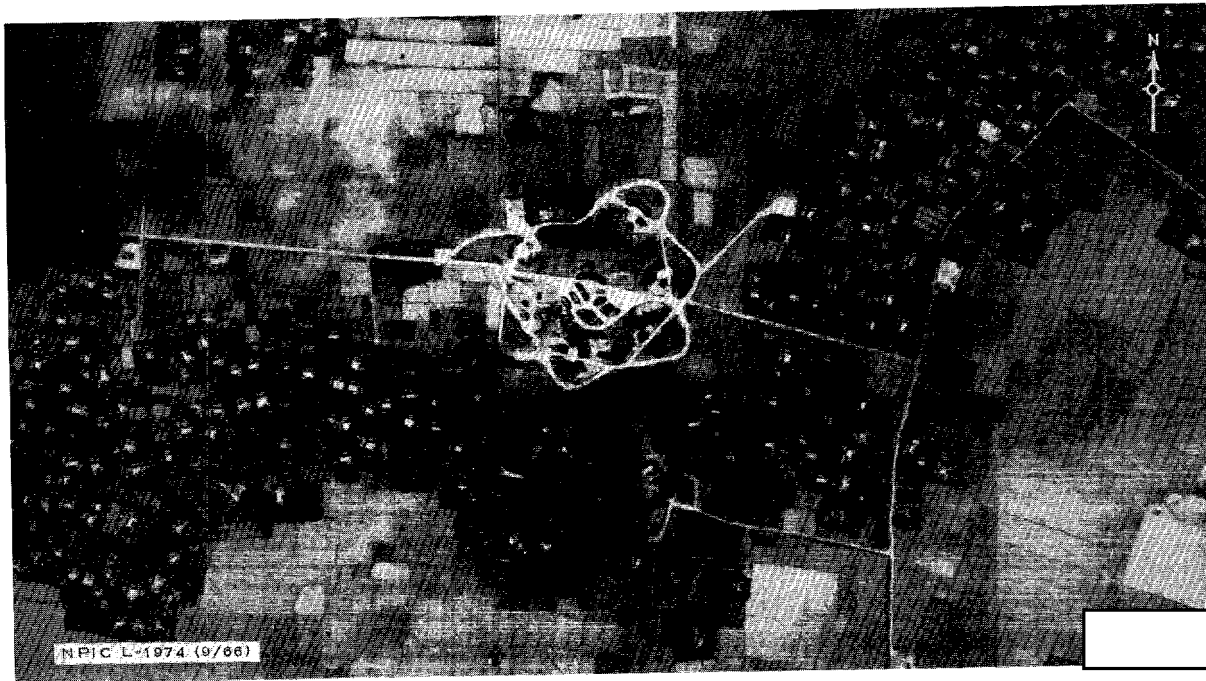
Hai Phong SAM Site A27-2

Location: 3.2 nm west of Hai Phong      Negation Date: Cannot be negated  
Configuration: Irregular  
Status: Complete  
Launch Facilities: 6 positions, revetted, unoccupied  
Electronic Facilities: Central guidance area is revetted, unoccupied  
Site Support Facilities: No buildings; no missile-hold positions  
Security Measures: None  
Remarks: 2 AAA sites visible within 1 nm

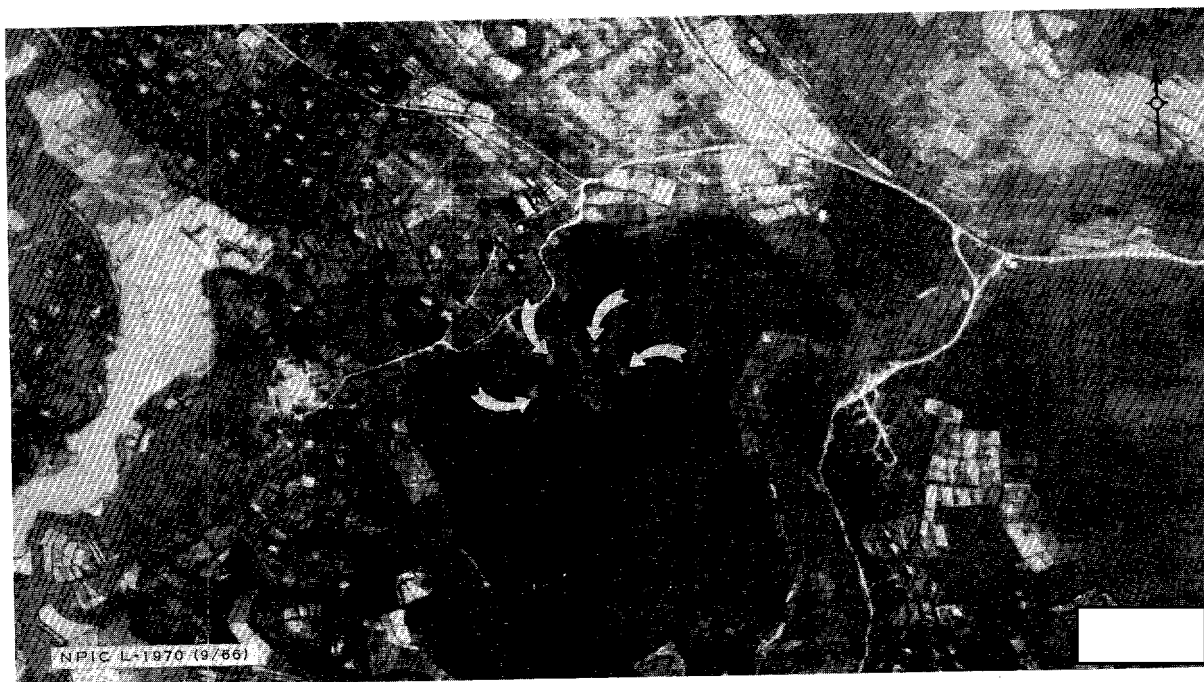
NAME  
Ha Noi SAM Site C3OE-2

Location: 29.8 nw NW of Ha Noi  
Configuration: Irregular  
Status: Complete  
Launch Facilities: 4 positions, unrevetted, unoccupied  
Electronic Facilities: Central guidance area is unrevetted, unoccupied  
Site Support Facilities: No buildings; no missile-hold positions  
Security Measures: None  
Remarks: 5 AAA sites within 1 nm
